# CIVIL AERONAUTICS BOARD

## AIRCRAFT ACCIDENT REPORT

NORTHWEST AIRLINES, INC.,  
LOCKHEED ELECTRA, L-188C, N 137US,  
O'HARE INTERNATIONAL AIRPORT  
CHICAGO, ILLINOIS, SEPTEMBER 17, 1961

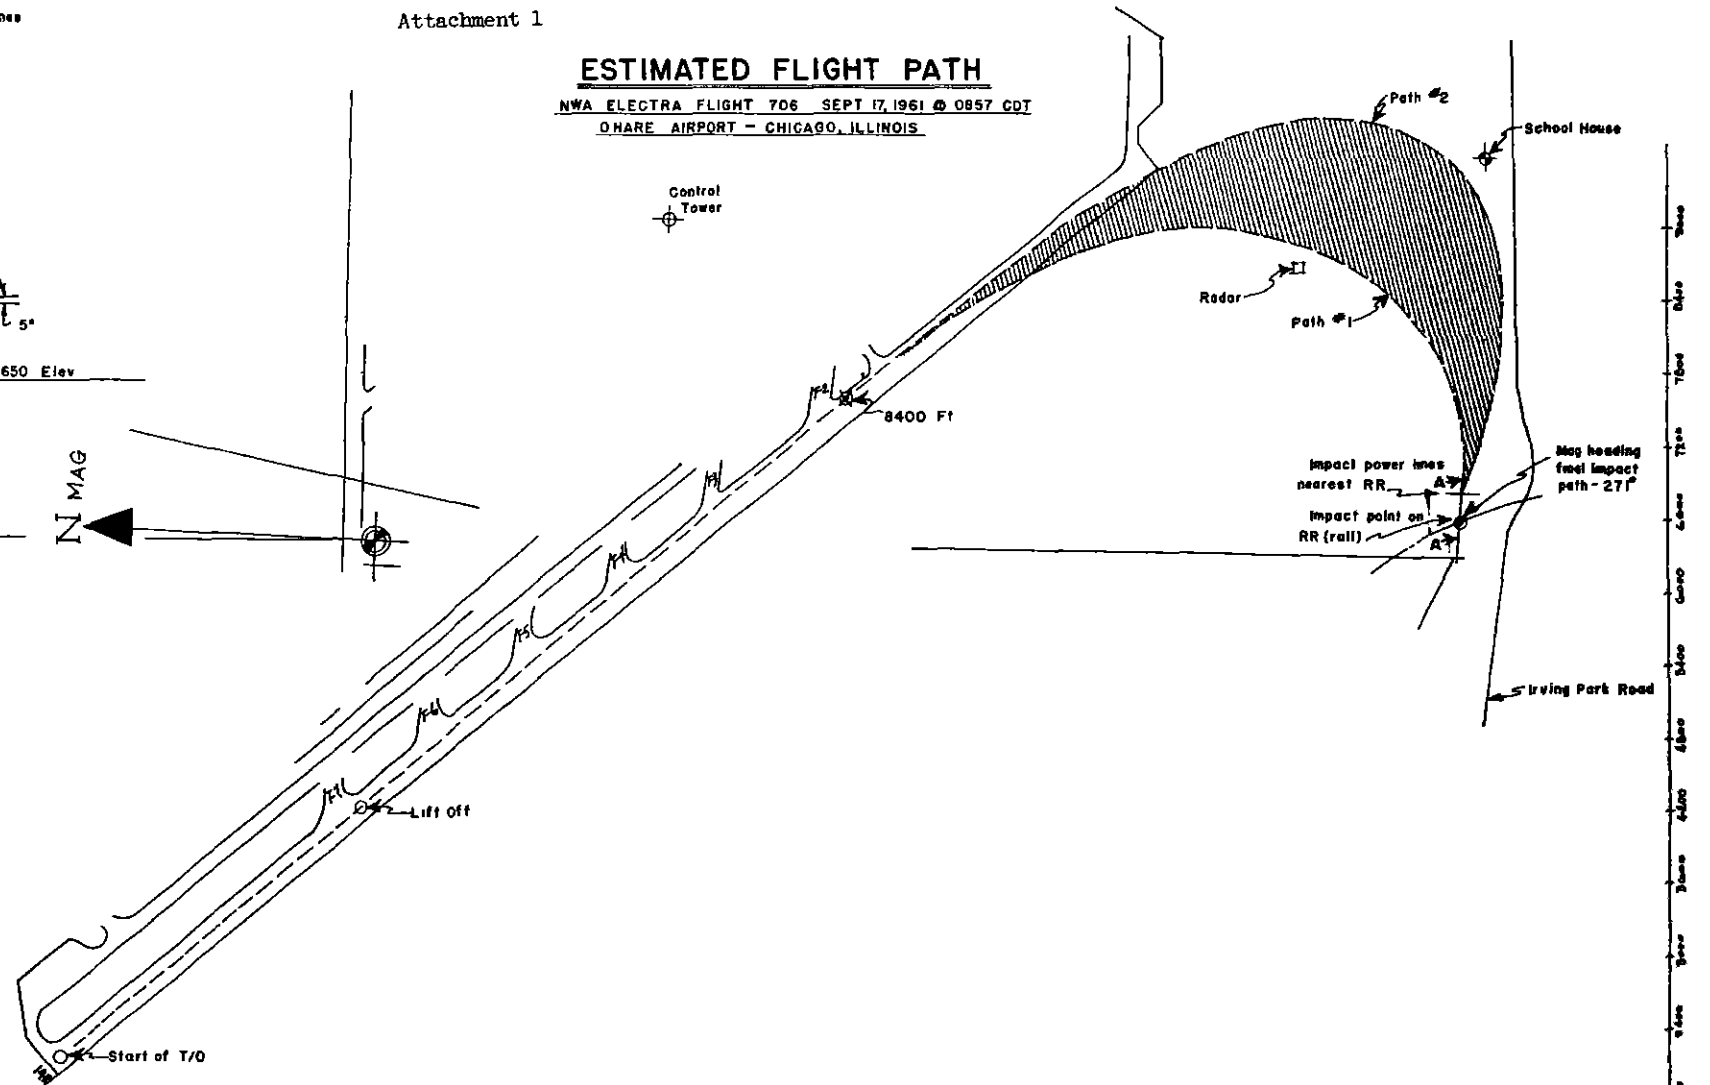
Attachment 1

To assist in developing a flight profile based on actual operation of Electra aircraft, tower personnel, at the request of Board investigators, conducted a survey of 44 Electra takeoffs. These takeoffs were sampled at random and were all observed when using runway 14R. The survey disclosed that the average lift-off was made when these aircraft were approximately 4,000 feet down the runway, and that when they reached the 8,000-foot marker, their altitude and airspeed indications were about 280 feet and 158 knots respectively. The airspeed was based on 28 pilot reports given to the tower. In addition, Lockheed Aircraft Corporation, in response to the Board's request, provided a study of the flightpath based both on L-188 performance data and information disclosed during the investigation. Their study encompassed a ground envelope of reported flightpaths but, based on performance data, the inner boundary was considered as the only possible flightpath. Based on the Lockheed study, Board investigators prepared the estimated flightpath chart. See Attachment #1.

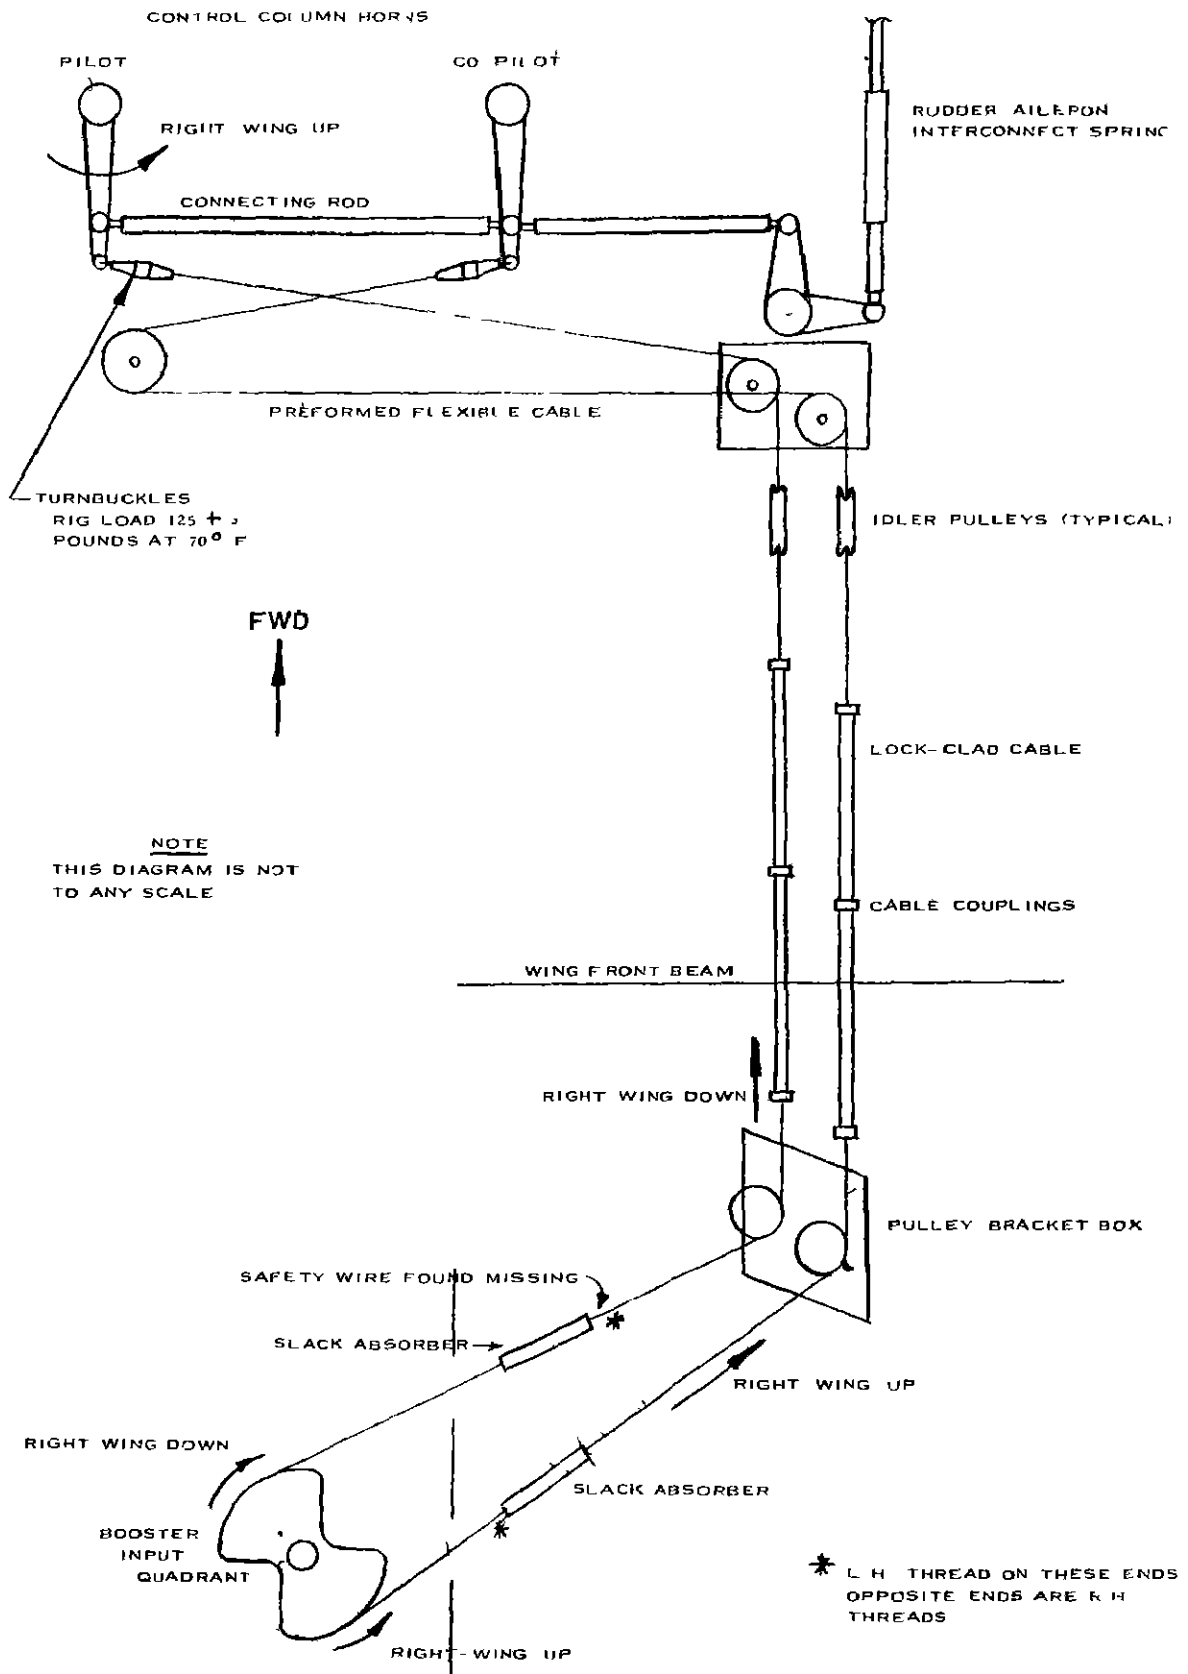
# AILERON PRIMARY CONTROL SYSTEM

From the aileron boost unit's input quadrant to both control wheels, the aileron primary control system consists of two cables which run through a series of pulleys to the control wheels, forming a closed loop.<sup>3/</sup> The cable which connects to the pilot's control horn is in tension for a right wing down control movement and the cable which connects to the copilot's control horn is in tension for a left wing down movement.<sup>4/</sup> These cables provide a signal input from the control wheels to the boost unit when the boost is engaged, and they also provide the physical link between the control wheels and the ailerons for manual operation when the boost is disengaged

The pilot's cable run starts with a 153.53-inch run of flexible cable routed athwartship to a pulley at Butt Line 34R, Water Line 128.5. From here, the cable consists of two consecutive 205-inch lengths of lockclad cables which run aft and down to a point just in front of a pulley bracket at Fuselage Station No. 651. A 39.25-inch flexible cable then joins the lockclad and passes through a 0.6-inch diameter guide hole in the front of the pulley bracket at Fuselage Station No. 651 and connects by a left-hand threaded stainless steel connector 4.2 inches long into the forward brass terminal block of a slack absorber unit. Proceeding from the aft brass terminal block of the slack absorber is a stainless steel, right-hand threaded connector attaching to a 42.01-inch length of flexible cable with a swaged ball fitting at the end which connects on the aileron boost input quadrant.

The copilot's cable is routed athwartship with a 200.34-inch length of flexible cable to a pulley at Butt Line 16.7L and then returned to the right side to a pulley at Butt Line 35R, Fuselage Station No. 127, and Water Line 132. From here aft, the run consists of lockclad cables identical with and parallel to the pilot's cable, and approximately an inch outboard. Just in front of the pulley bracket at Fuselage Station No. 651, a 43.75-inch flexible cable connects to the lockclad and passes through a 0.6-inch diameter guide hole in the front of the pulley bracket approximately one inch to the right and one-half inch below the pilot's flexible cable guide hole. After this, it joins a slack absorber unit with identical stainless steel fittings as on the pilot's side except that the forward one is right-hand threaded, and the rear, left-hand threaded. A 28.88-inch flexible cable with a swaged ball on the end connects the cable to the aileron boost input quadrant.

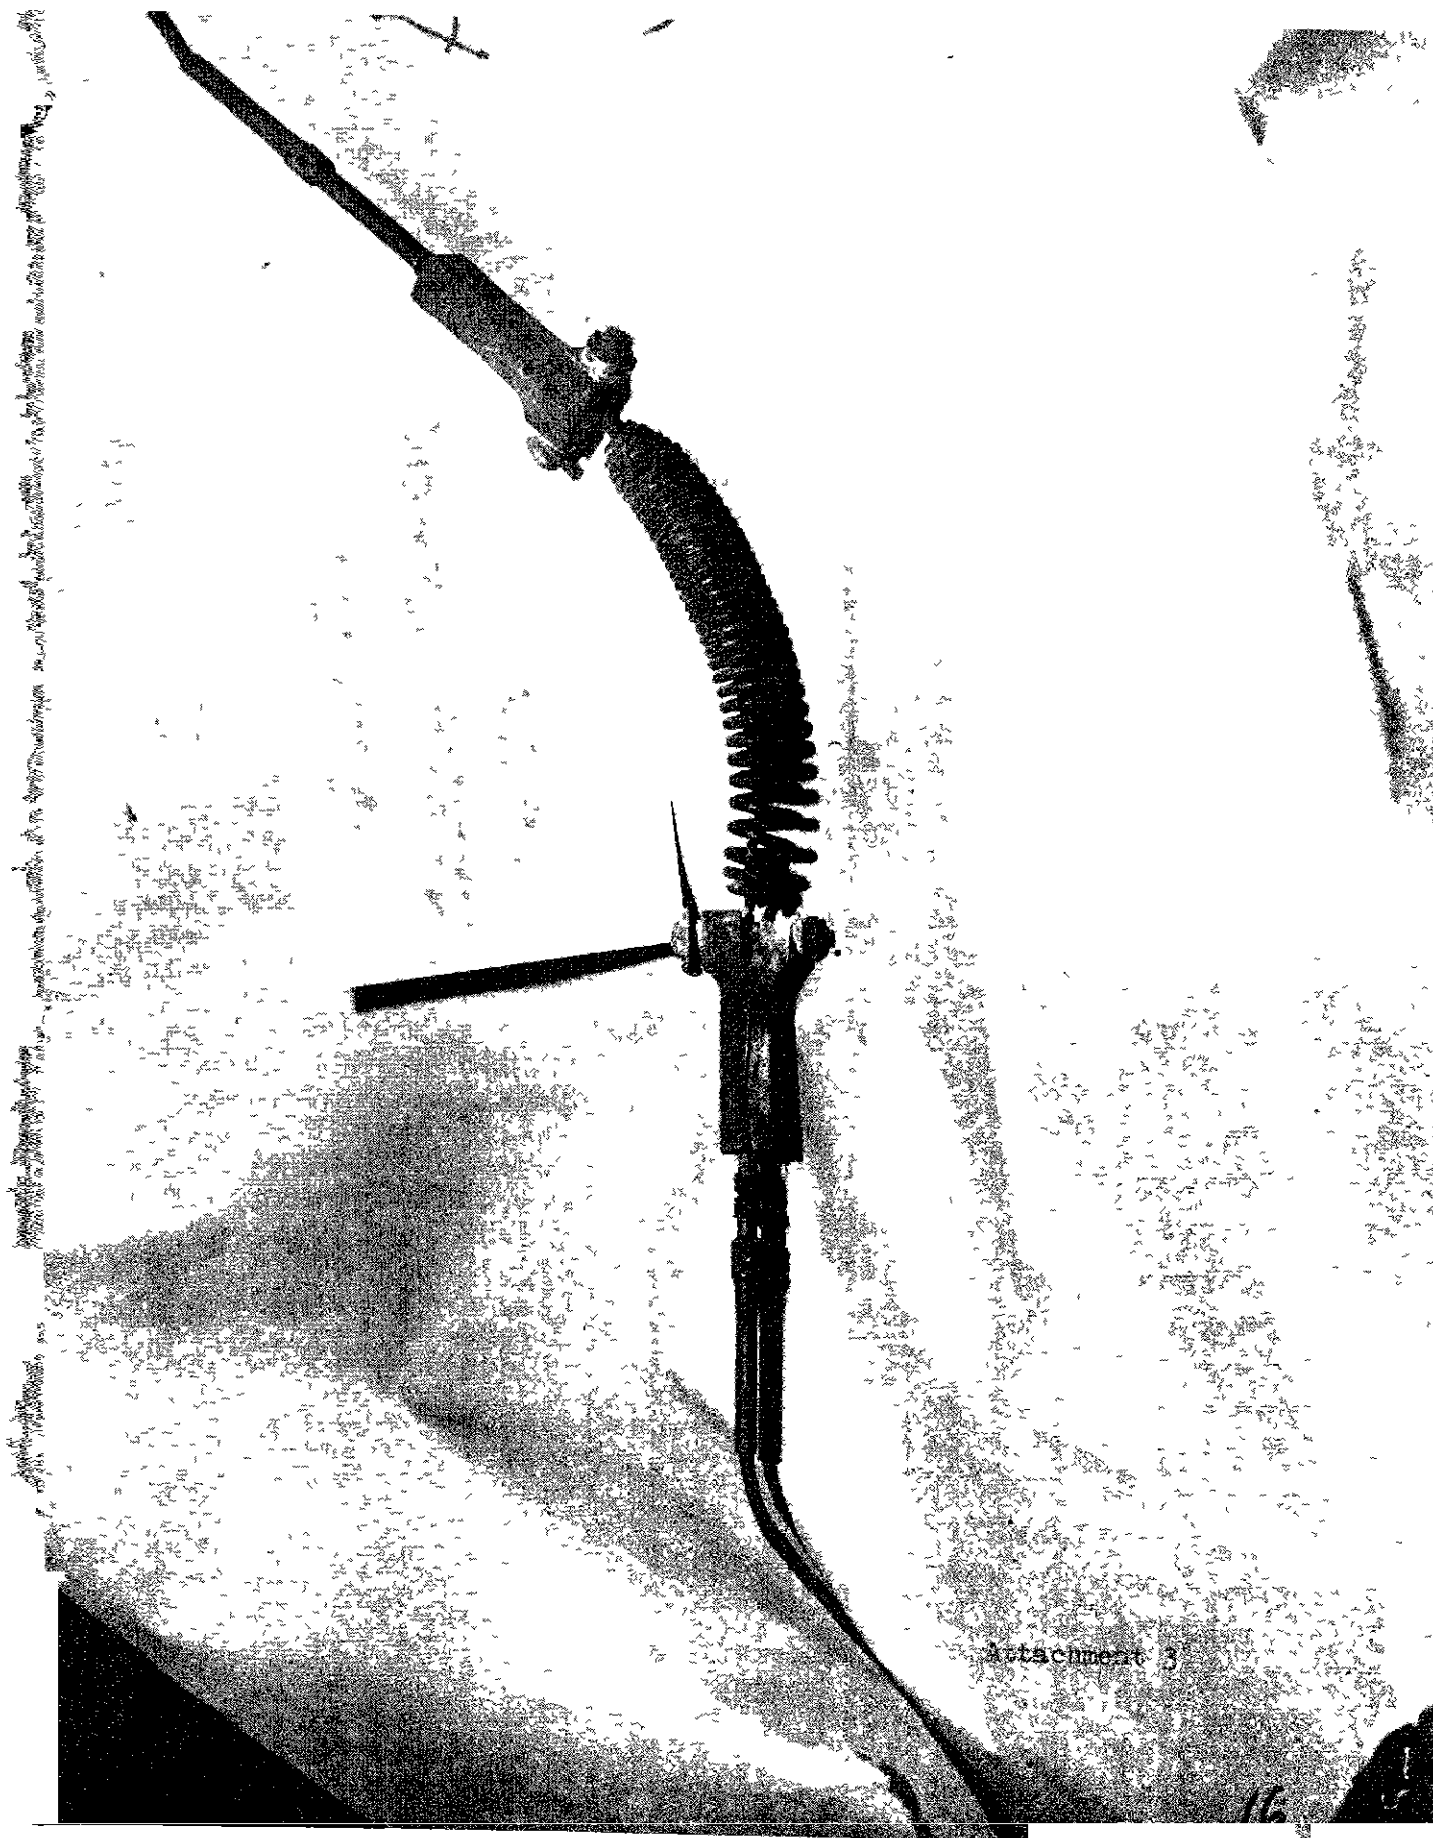
Attachment 3

Between the pilot's control column horn and the aileron boost input quadrant, all recovered cable connections were found to be normal except for the threaded connector of the slack absorber forward terminal block. This connector was found unsafetied and was backed out of the terminal block, showing five to seven threads

for a 0.40-to 0.45-inch engagement.<sup>5/</sup> This slack absorber unit, minus its aluminum side plates, is shown in Attachment #3. The forward connector (shown on the right in Attachment #3) should be safetied with steel wire exactly like the aft connector (on the left in Attachment #3). Distinctive lines on the surface of the slack absorber's aft connector showed where safety wire had shielded these surfaces from fire and soot. In contrast, no such distinctive lines could be found on the forward connector in question. Laboratory examination by the National Bureau of Standards and the Federal Bureau of Investigation revealed no evidence of safety wire having been recently installed on this connector.

As previously indicated, examination of the aileron primary control system revealed that the right wing down cable connector which screws into the forward terminal block of the pilot's slack absorber unit was not secured with safety wire and was unscrewed to an engagement of only 0.40 to 0.45 inches (normal engagement, 1.2 to 1.45 inches). This condition can be attributed to either the natural tendency of an unsafetied cable to unwind or that this was the position to which the connector was unscrewed during the aileron boost unit change. The pilot's cable was
